MSHA's Accident Prevention Program Safety Idea

Hazards Created by Heating Closed Chambers

Category : Maintenance

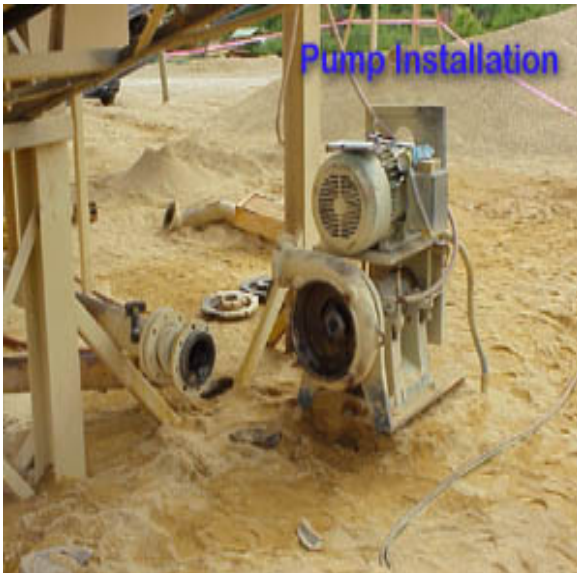
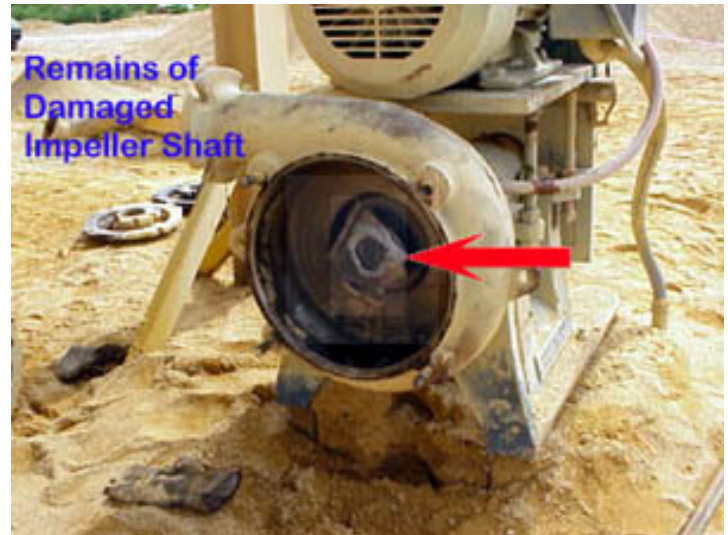
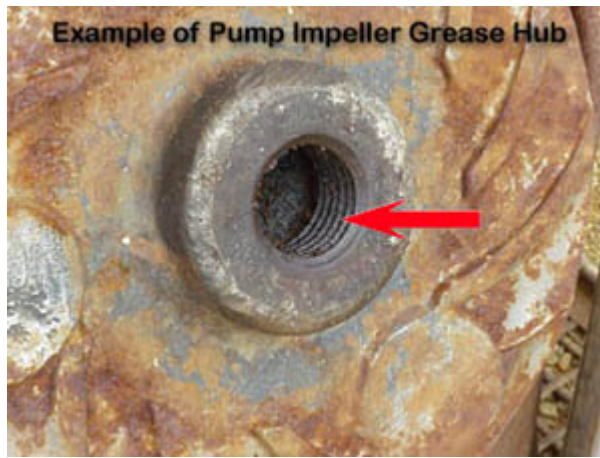
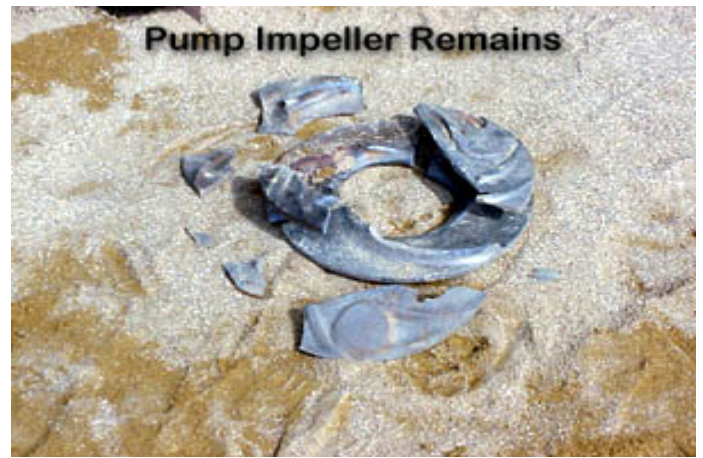
A common accident in the mining industry occurs when heat is applied to equipment during maintenance. The use of oxygen-acetylene torches to apply heat is a common tool on mine sites. It makes many tasks easier, but can also cause problems. Applying heat to a closed chamber will create a build-up of pressure, and in many cases cause an explosion. If lubricants are used, this can add an additional source of energy to the explosion. Below are pictures of a slurry pump impeller hub involved in a fatal accident. An analysis of this accident found:

Did not refer to the operation manual.

Used pipe wrenches, steel pry bars, and hammers. Did not use the special tool recommended by the manufacturer to remove the impeller.

Possibly was attempting to remove the impeller by applying torque in the wrong direction. This unit uses standard threads not reverse threads.

Heated a closed containment (impeller hub) that contained combustible materials (grease or anti-seize compound).

Maintenance manuals to reference every time unfamiliar or technical maintenance work is attempted

A **special tool** by the manufacturer that locks the impeller in place so that the pump shaft can be rotated loosening the impeller. **The manual indicates the correct rotation.** The special tool only operates when the shaft is **rotated the correct direction.**

Read and followed manual and two warning labels on the pump legs which cautioned against heating impeller hubs.

Never heat an enclosed or confined space on a piece of equipment except as directed by the manufacturer.
